RE: November Monthly Report
1.5 Mile Reach Removal Action
GE-Pittsfield/Housatonic River Site

Figure 1- 1.5 Mile Removal Action Site Map (2 maps)

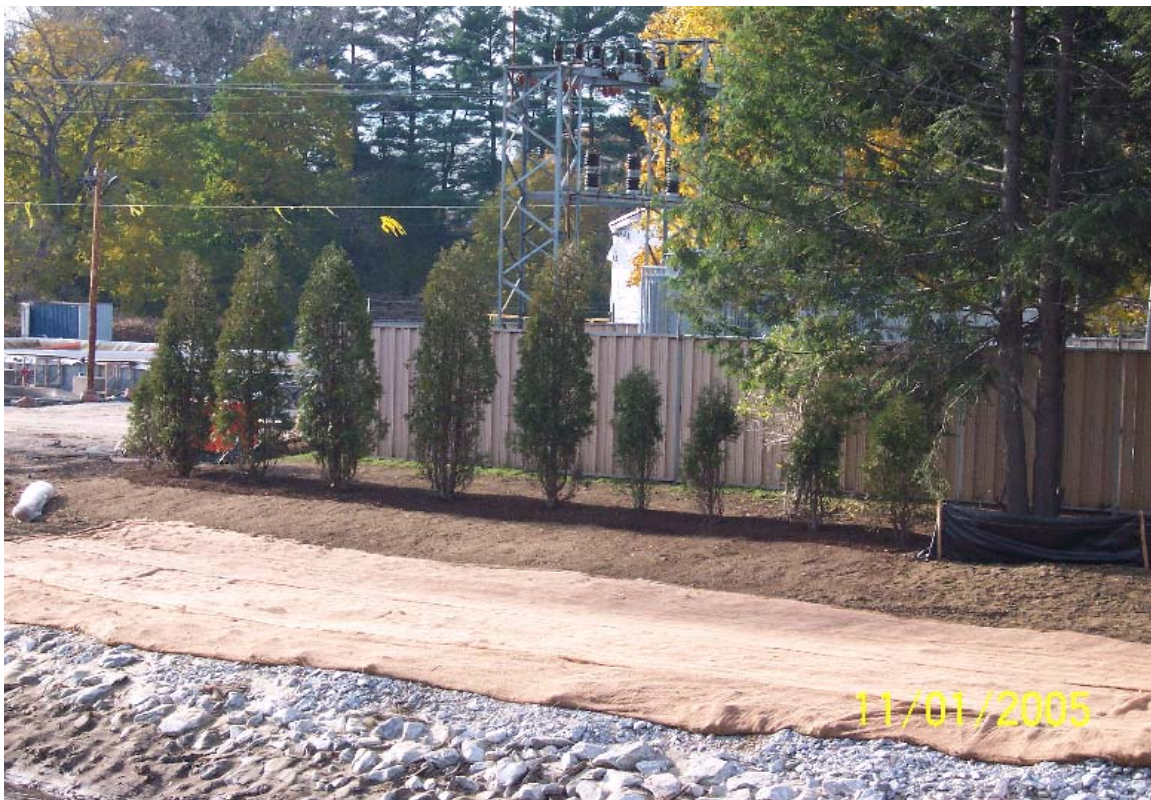
Photograph 1 – Final Restoration on Parcel I7-1-5

In addition, work on the former support area on Parcel I7-1-5 was performed. One truck load of debris was removed from the Cell 36 riverbank adjacent to Parcel I7-1-5 and transported to Area 64E stockpile management area. Additional topsoil was installed and hay mulch was placed on the newly top soiled and seeded area. Also, final lawn restoration and repairs were made to the topsoil on Parcel I7-2-21, former crane pad location.

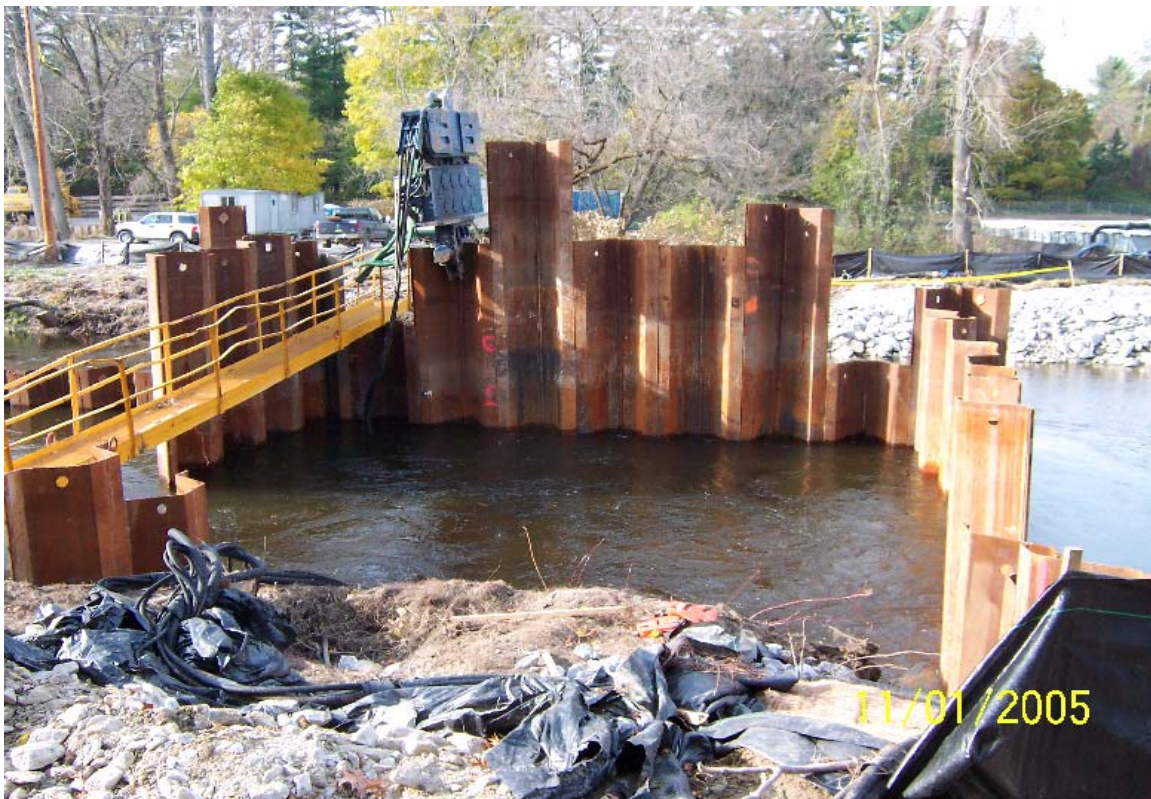
Photograph 2 – Installation of the Centerline Sheetpile Wall in Cell 38S

By the end of October 2005, the upstream cutoff wall for Cell 38S (former Cell 38 downstream wall) was pulled up to grade from mud line and activities associated with the installation of the centerline sheetpile wall for Cells 37S/38S were initiated. During the first week of November, the installation of the centerline sheetpile wall for Cells 37S/38S was completed. The centerline sheets were driven very carefully to embed on top of the sewer siphon structure without damaging the structure. Also, the installation of the downstream sheetpile cutoff wall for Cell 38S was completed. Due to the high water flow underneath the centerline sheetpile at the sewer siphon, the riverbank adjacent to the downstream wall started to erode. The downstream wall was immediately removed and super sacks filled with common fill were installed along the outside of the centerline sheetpile wall to control the water breach into the cell. Then, the downstream sheetpile wall was re-installed. This time the sheetpile was driven through the super sacks filled with common fill to ensure the wall was properly sealed.

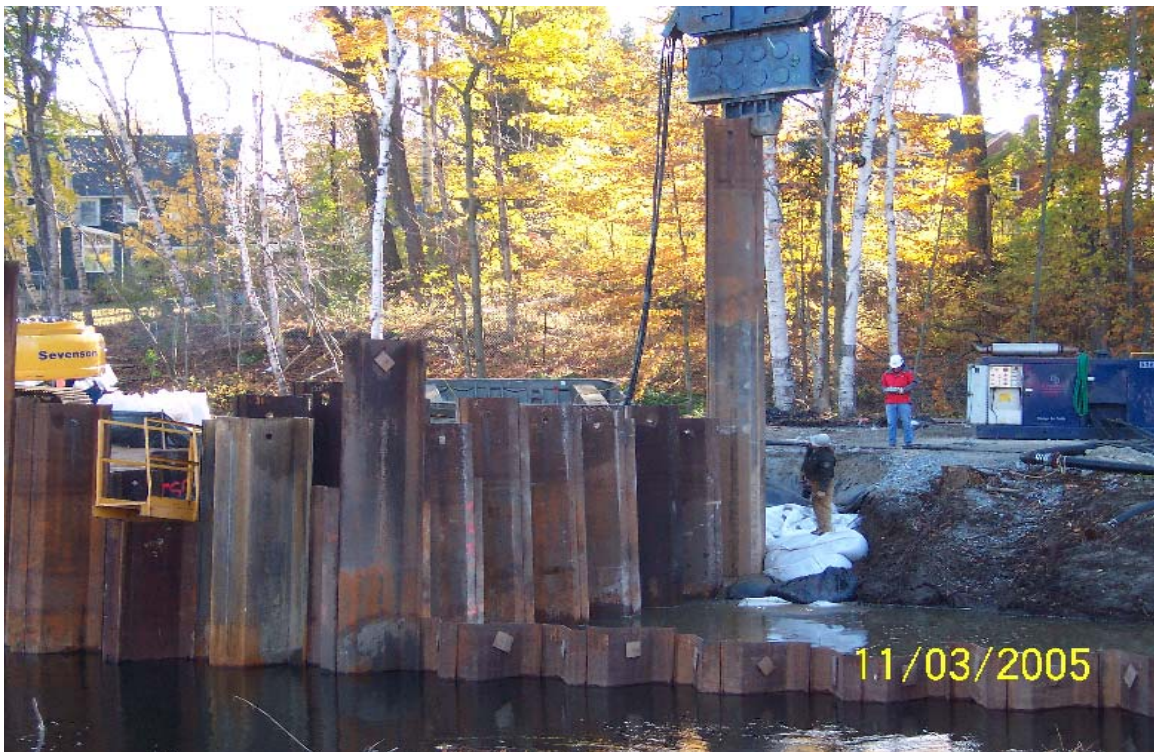
Photograph 3 – Installation of the Downstream Sheetpile Cutoff Wall through Super sacks in Cell 38S

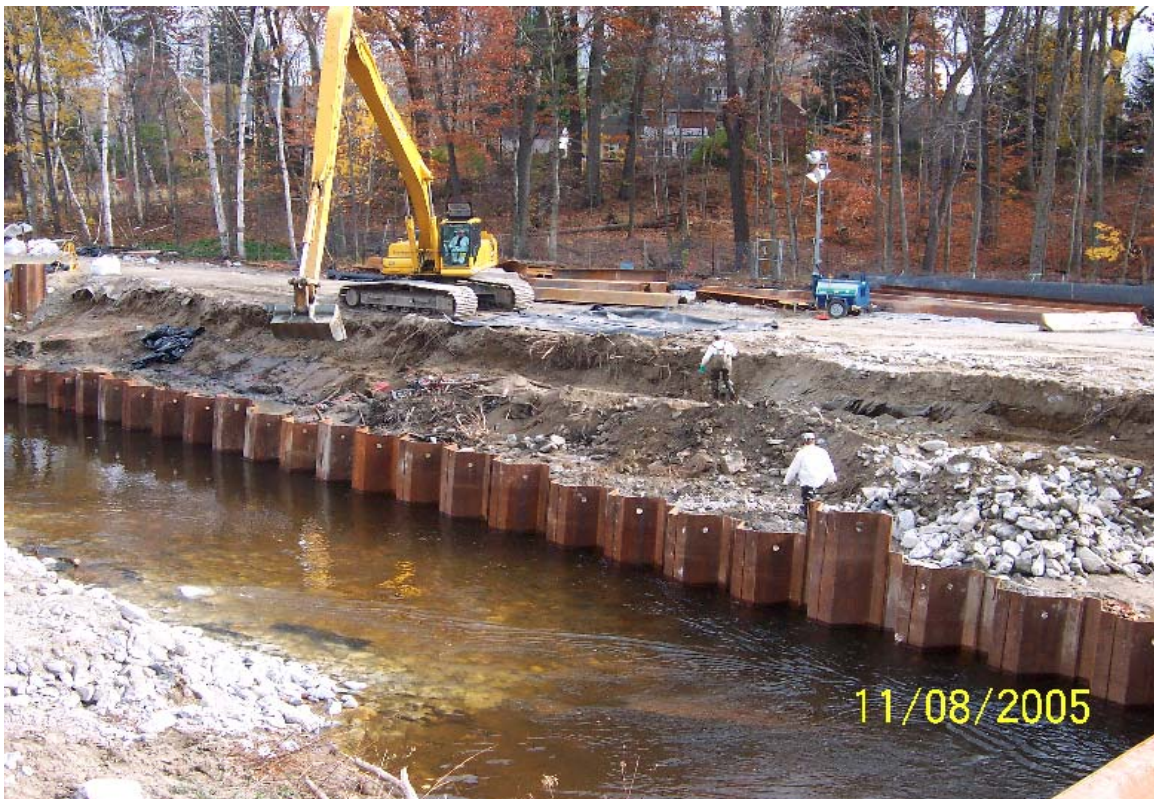
Photograph 4 – Excavation Activities in Cell 38A

The installation of the Cell 38A downstream sheetpile cutoff wall was completed. Once Cell 38A was isolated, the dewatering activities were initiated by pumping water greater than 6-inches in depth directly back to the river. Once the water depth reached 6-inches, it was pumped to the WTS. Sumps and swales were installed to help in the dewatering process. Once the dewatering was completed, the survey contractor completed the delineation of non-TSCA and TSCA excavation areas in Cell 38A and excavation activities in Cell 38A were completed. A small section of the floodplain in Cell 38A adjacent to the top of riverbank where GE anticipates performing subsequent remediation on floodplains was remediated and restored by EPA's contractors. The excavated TSCA material was transported to Building 63 and Building 68 stockpile management areas. The non-TSCA material not characterized for off-site disposal was transported to Area 64D north, Area 64D south and Area 64C north stockpile management area.

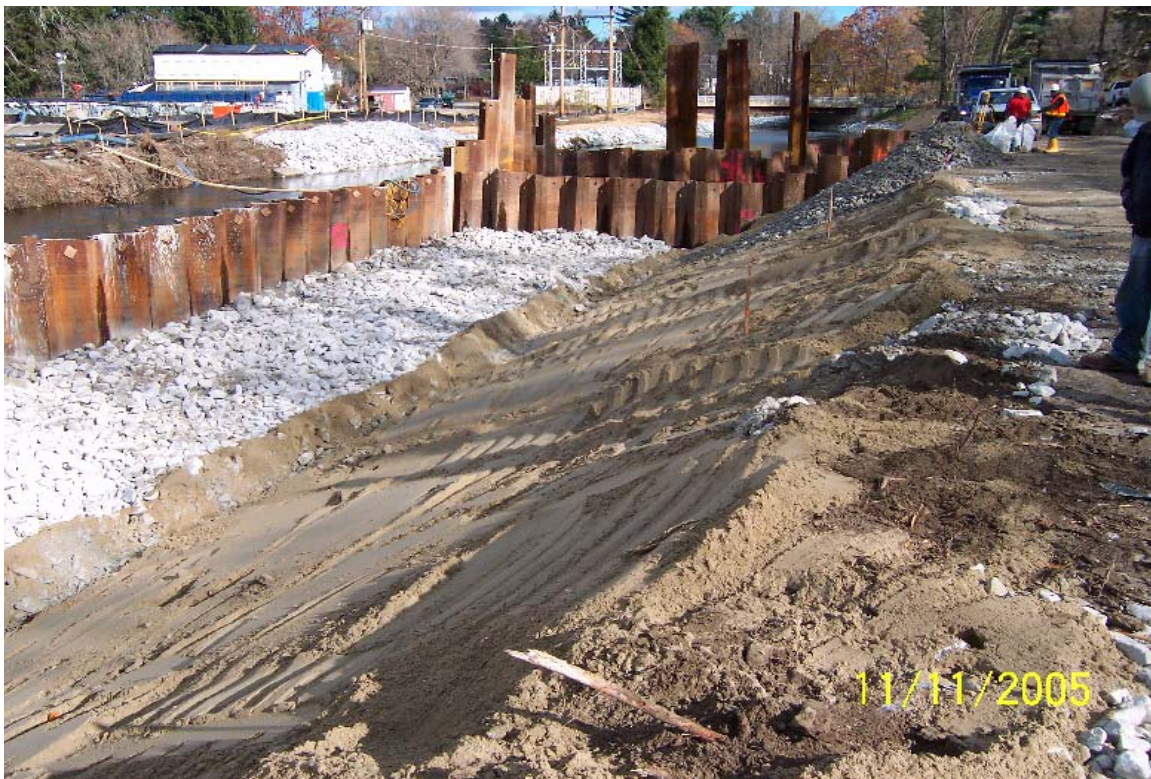
Photograph 5 – Backfilling Activities in Cell 38A

The riverbed and riverbank of Cell 38A and 40S were backfilled as follows: The riverbed in Cells 38A and 40S did not require a common fill layer. A layer of common fill was only to be placed in areas that were over excavated, such as sumps and trenches. In Cell 40S, filter material type I was used instead of common fill to bring the riverbed up to grade because backfilling was done "in the wet". Next a ten-inch layer of filter material Type I, and a fifteen-inch layer of 9-inch riprap were placed. The riverbanks were backfilled with common fill to the design grade, a nine-inch layer of filter material type I and a twenty four-inch layer of 18-inch riprap up to approximately elevations 966.0 feet and 966.5 AMSL. In Cell 40S 18-inch riprap was placed all the way up to the sewer siphon structure which is located beyond elevation 966.5 feet AMSL.

The riverbank beyond elevations 966.0 feet and 966.5 AMSL in Cell 38A will be backfilled with common fill to within 6-inches of final grade. The common fill will be installed in twelve-inch horizontal lifts and compacted to meet the 95% compaction requirement. Next, the riverbank will be backfilled with a 6-inch layer of topsoil, and then herbaceous seed and erosion control blankets will be placed. Due to the location of the access road, heavy traffic adjacent to Cell 38A and the subsequent remediation activities in the "GE floodplain area", topsoil, herbaceous seed and erosion control blankets will be placed only in the first twenty-five feet of the Cell 38A riverbank at this time. The rest of the Cell 38A and Cell 40S will be backfilled at a later date.

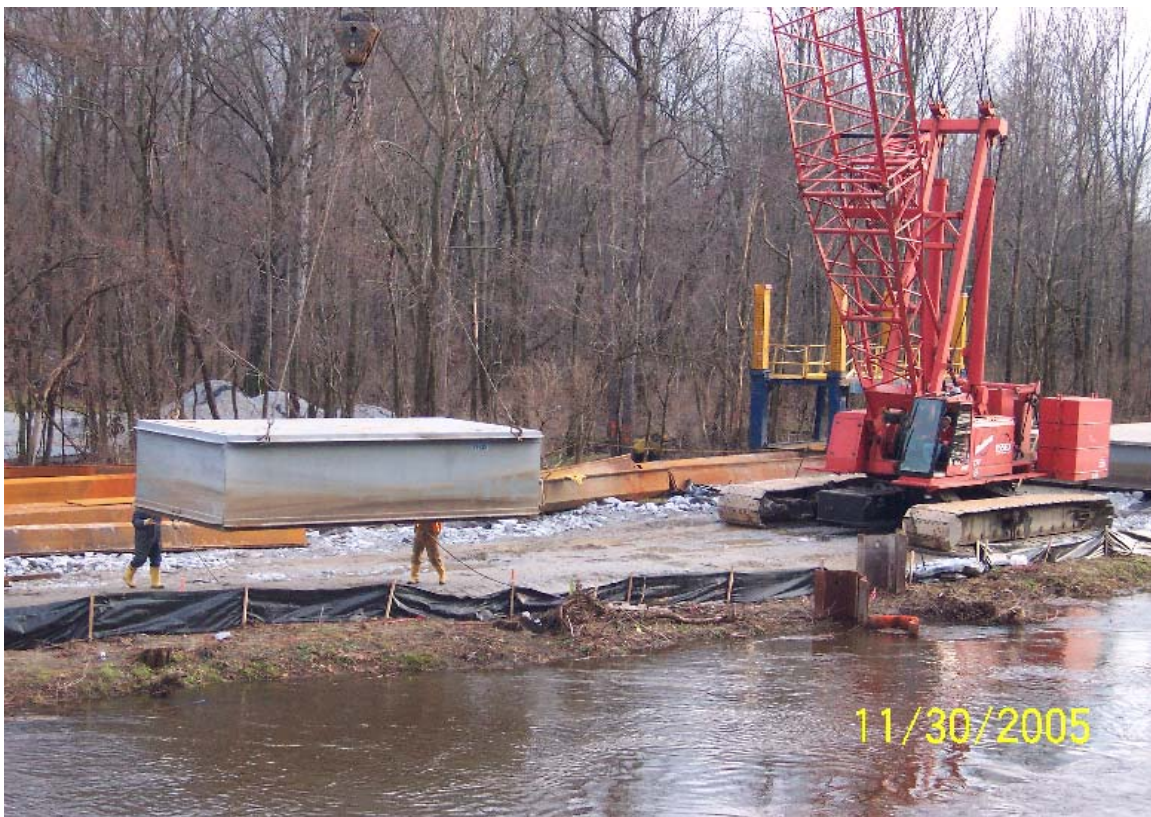
Photograph 6 – Unloading of the Barge for Floating Barge River Crossing

During the last week of November, activities associated with the installation of the temporary floating barge river crossing were initiated. First, the surveyors staked out the proposed location for the barge crossing. Next the riverbed where the barges will be located was trenched and leveled off by excavating approximately a three-foot layer of sediment from the area. The trench will ensure that the barge will not bottom out when the loaded dump trucks cross it. The excavated sediment was placed in a roll off box for dewatering and then transported to Building 65 stockpile management area. Also, the deliveries of the components for the barge were initiated.

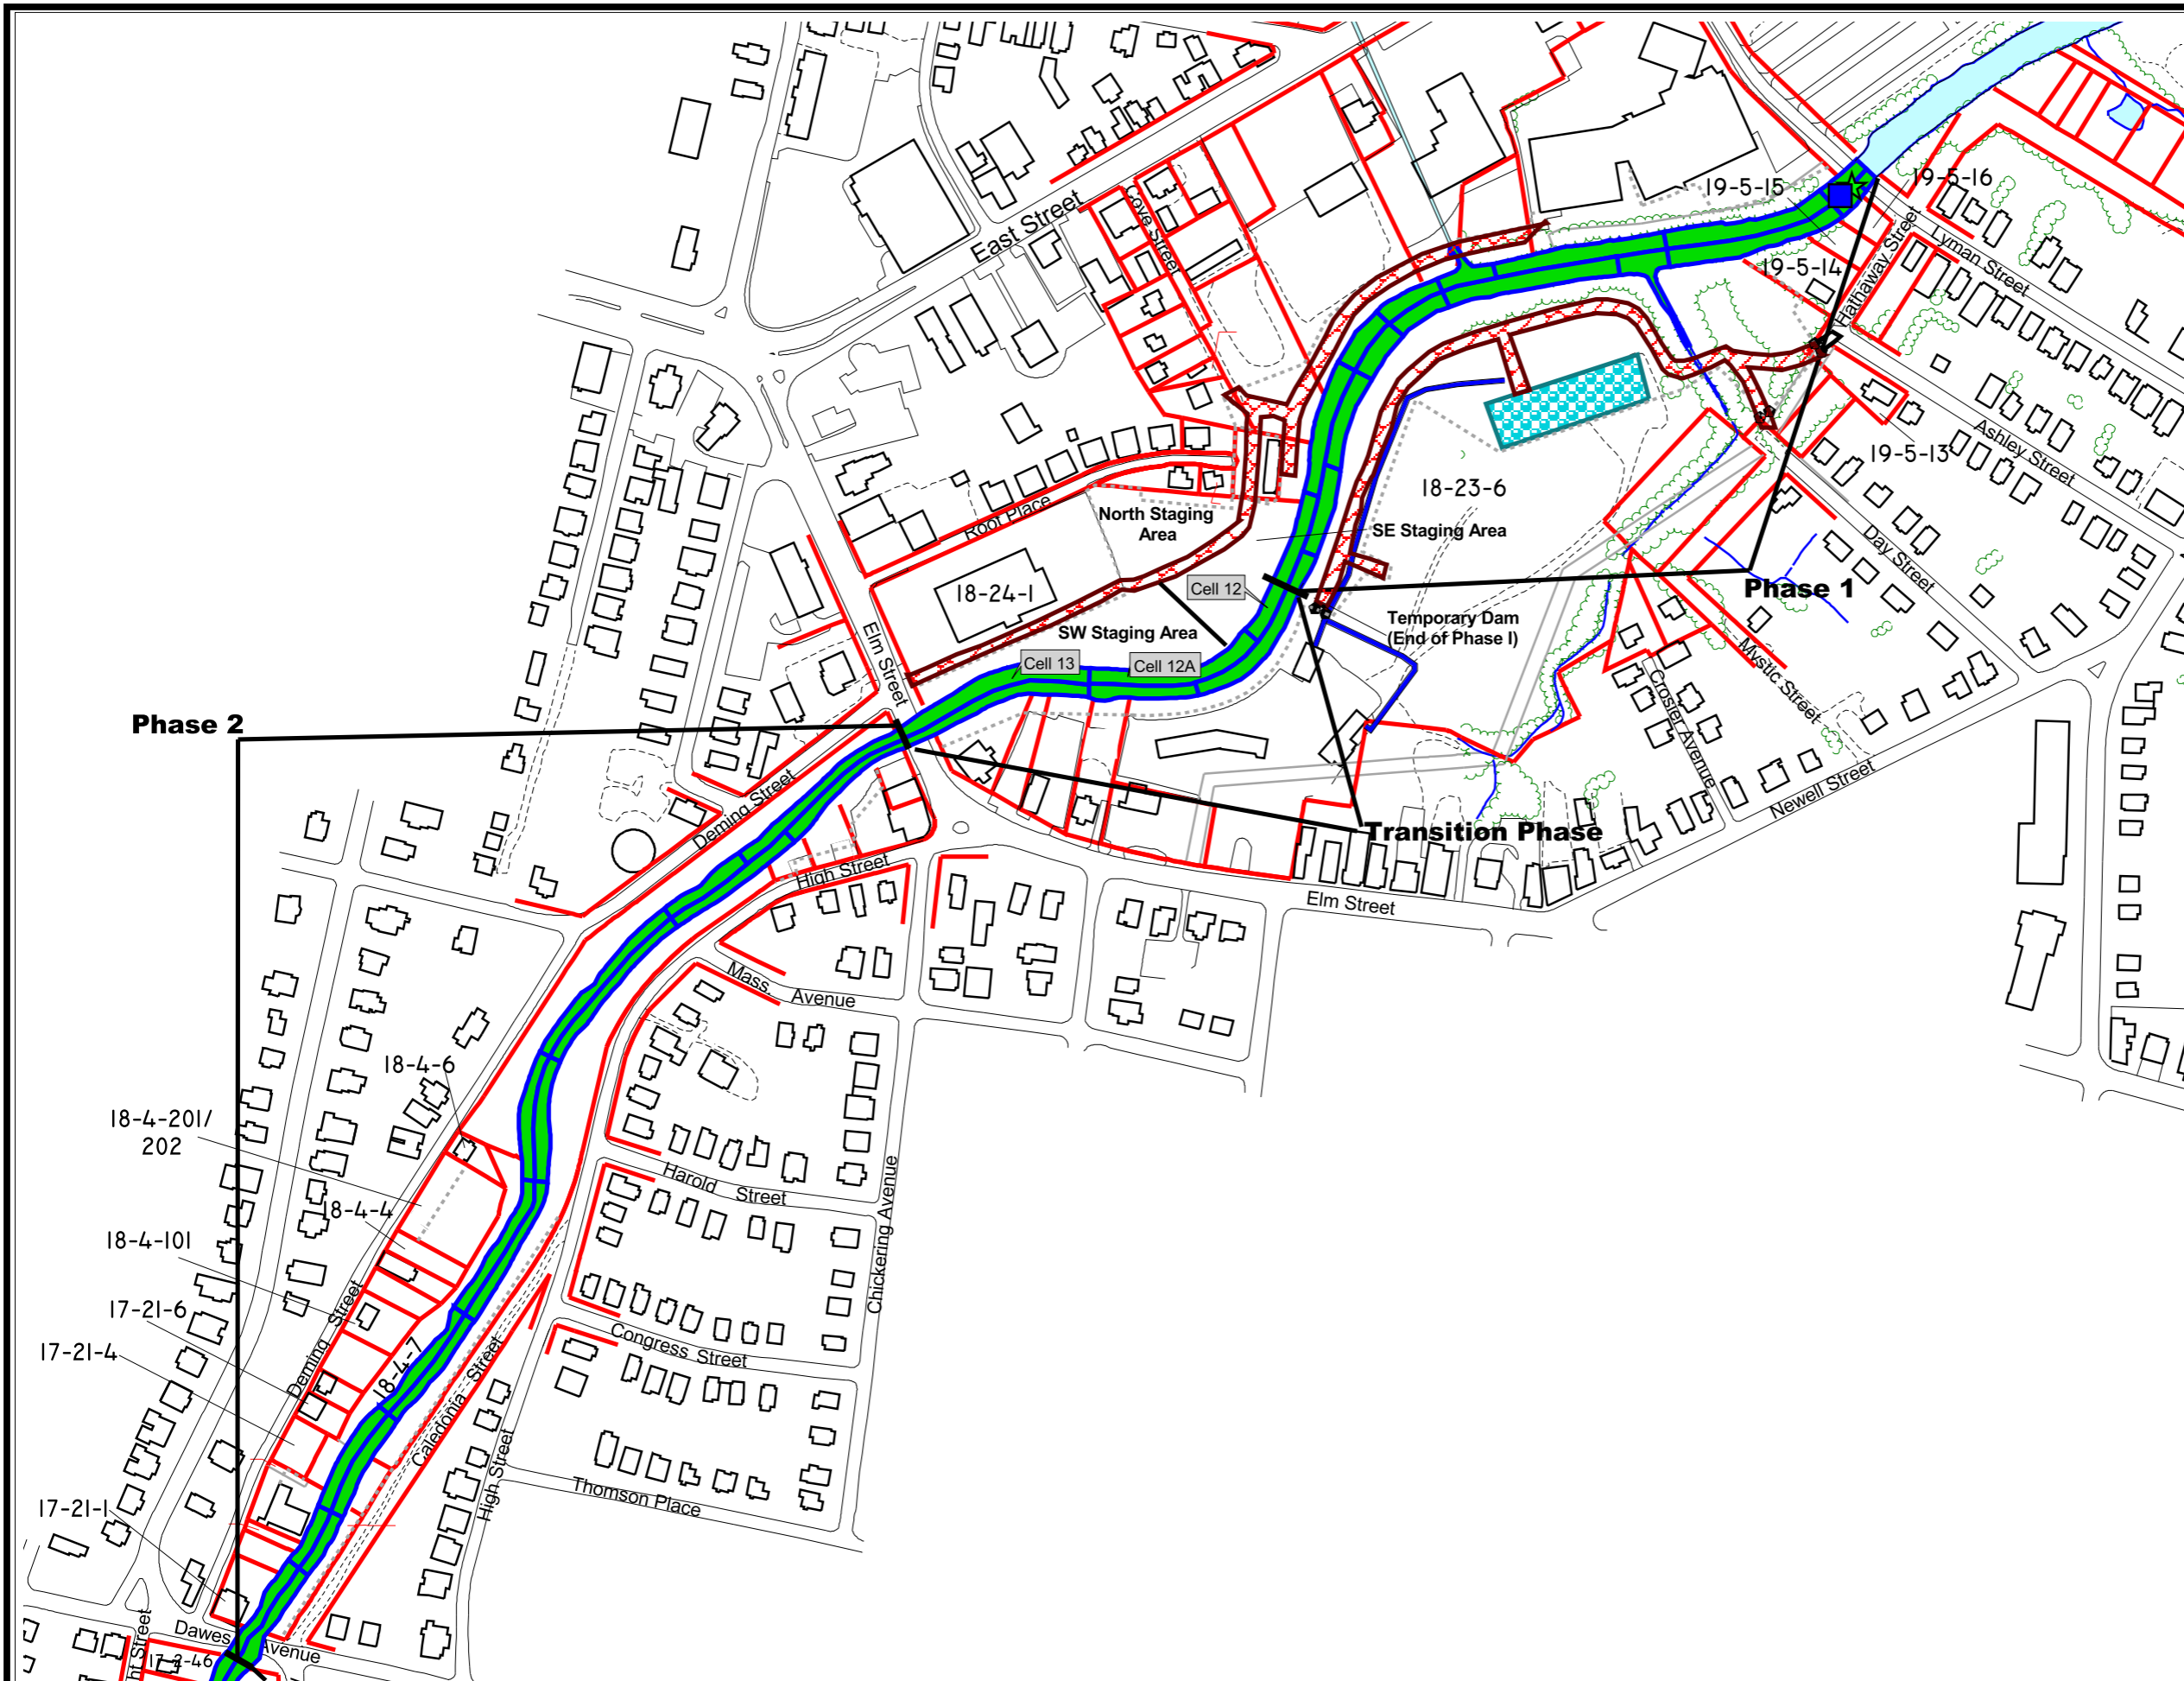
Figure 1
1.5 Mile Removal Action
Site Map (Map 1 of 2)
November 2005 Monthly Report

Figure 1 (2 maps) includes the layout of all excavation cells, the temporary dam, water monitoring locations, air sampling locations, vibration monitoring locations, access road locations, excavation load-out locations, staging area locations, fence line location, and the new and the old water treatment system pad locations.

Refer to Figure 1 (2 maps) for an orientation of the excavation cells and their respective locations.
